General Aviation Airworthiness Alerts

AC No. 43-16

**ALERT NO. 221
DECEMBER 1996**

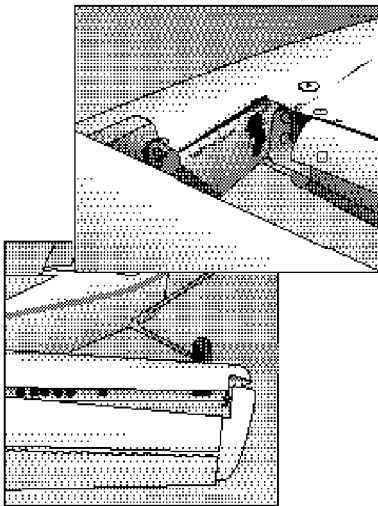
**Elevator Failure
5552**

This aircraft was being used for flight instruction. The student pilot informed the flight instructor, that during the flight, the elevator "did not feel right." The elevator system problem was not reported or entered into the maintenance records, and no action was taken. The next day, the right elevator hinge bracket failed completely during a student pilot solo flight. Although extreme difficulty was experienced in maintaining control of the aircraft, a safe landing was made.

The right elevator did not separate from the aircraft. (Refer to the following illustration.) While investigating the cause of this failure, the bushing (P/N 0432003-1) used for rotation of the parts was found conical shaped. The submitter speculated this was due to "wear and age." The small conical shaped area caused the end of the bushing to cut into the hinge brackets, causing the hole to elongate. The submitter suggested closer attention be given this area during scheduled and preflight inspections. In addition, the elevators should be removed each 1,000 hours for examination of the bushings for unusual wear patterns and/or corrosion. The hinge brackets should be checked for wear and the elevator spar for cracks. Proper lubrication of this area is vital to proper operation. This defect should have been discovered during preflight inspection. Slight hand pressure applied to the elevator surface in a "wiggling" motion would have revealed this dangerous problem.

Part total time-7,706 hours.

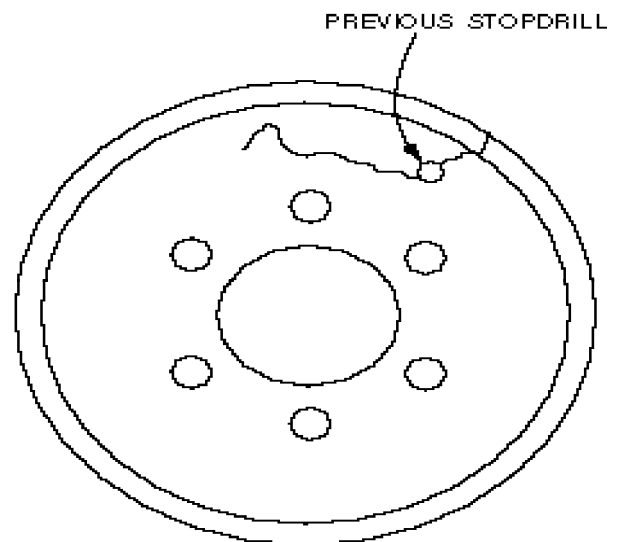
**Cracked Propeller
Spinner Bulkhead
6113**

The propeller spinner bulkhead was found cracked during an annual inspection.

This cracked existed for some time as evidenced by a "stop drill hole" from which the crack had continued. (Refer to the following illustration.) The cause of the initial crack could not be determined; however, it continued because of "improper stop drilling." The spinner bulkhead (P/N 35323-12) was no longer serviceable and had to be replaced. Before any repairs to this area are accomplished, the manufacturer's technical data should be consulted.

Part total time-1,700 hours.

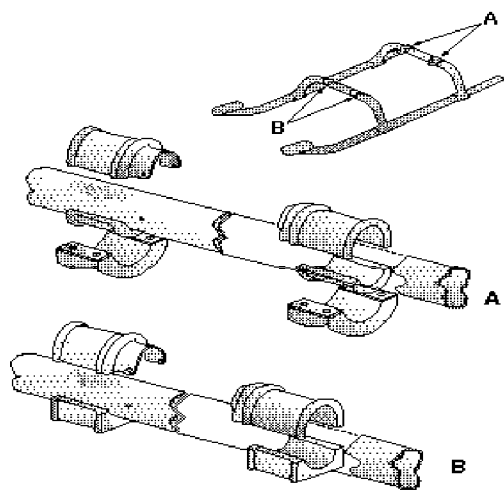
American Eurocopter	Landing Gear Cross
Model AS-350B1	Tube Corrosion
Ecureuil	5344

This operator reported finding severe corrosion under the chafing strips installed on the forward-and-aft landing gear cross tubes.

After finding minor corrosion adjacent to the cross tube attachments, they were removed, exposing severe corrosion under the chafing strips. (Refer to the following illustration.) The severity of this corrosion required replacement of both cross tubes. Corrosion in these areas is usually not detectable without removal of the cross tube attachment. The submitter recommended the manufacturer revise their technical data to require removal and inspection of the cross tube attachment area during scheduled inspections. Any sign of corrosion adjacent to these fittings should be thoroughly investigated by removal of the cross tube attachment and chafe strips.

Part total time-1,948 hours.

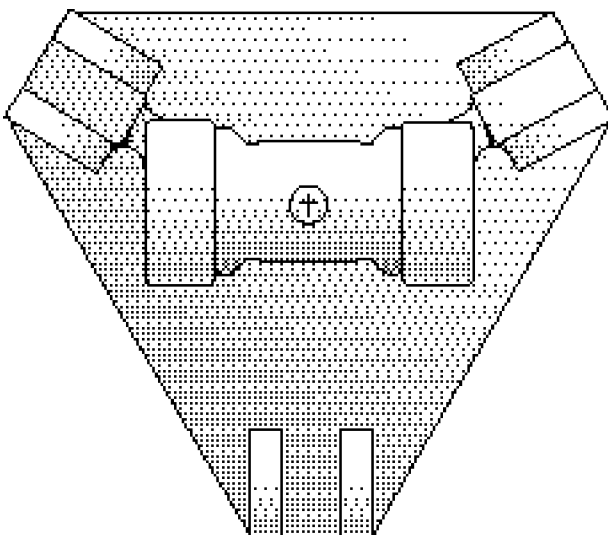
**Swashplate Cracks
6230**

Cracks were found between the swashplate control rod and the universal yoke while a scheduled inspection was being accomplished.

The cracks ran down the yoke (P/N 28-16119) web at two locations. (Refer to the following illustration.) It appeared both cracks originated at the edge of a "machining line" in the metal. The cracks were observed visually and by use of nondestructive testing. The submitter stated this was the second swashplate found in 1 month with similar cracks. Both parts had accumulated approximately the same number of operating hours.

Part total time-4,393 hours.

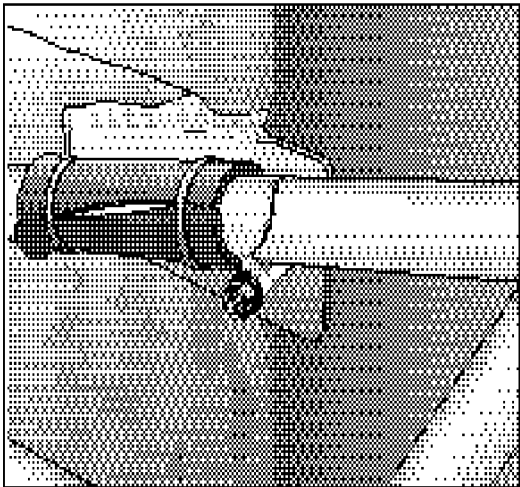
**Broken Oil Tank
Support
5345**

In the process of an annual inspection, an engine oil tank mount tube was found cracked.

The cracked tube was located at the right rear oil tank mounting point. (Refer to the following illustration.) The crack traveled around more than the entire circumference of tube in a spiral direction. A further inspection of the tube interior did not reveal any

corrosion or other cause for this defect. This area deserves close attention during scheduled inspections.

Part total time-3,673 hours.
